Building Survey Report

Property inspected:

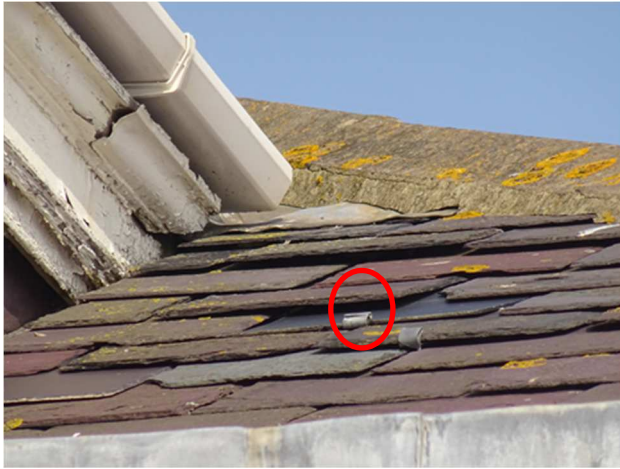
1

The front being in the worst condition with a number of cracked and missing slates (See Appendix A Photograph 1, highlighted in red). Some of the slates are held in place with metal clips called Tingles indicating that the nail fixing has been lost (See Appendix A Photograph 2, highlighted in red). Although it may be possible to continue with such repairs for a limited period, eventually the entire covering will have to be renewed. The rate of deterioration and hence the timing of renewal cannot be predicted with accuracy.

The roof covering requires an overhaul to deal with missing and cracked slates to ensure watertightness. You should obtain estimates for this work from a competent roofing contractor.

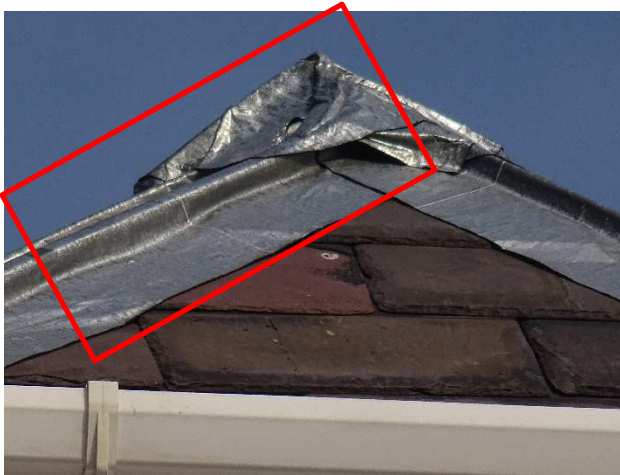
3

It was noted that the hip elements are possibly in Lead (See Appendix A Photograph 3, highlighted in red). This however appears to be inadequately clipped and there is a risk that this can be lost during high winds

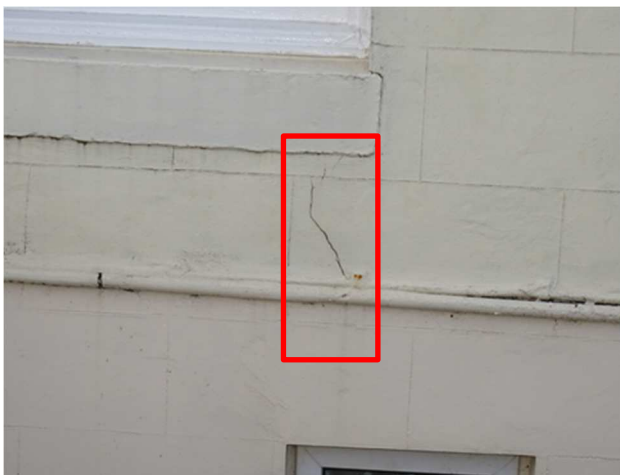
5

Cracks were noted to the rear elevation between the windows on the basement and ground floor (See Appendix A Photograph 5, highlighted in red) and ground floor and first-floor (See Appendix A Photograph 6, highlighted in red)

The walls have been covered with render and this hides the areas where the settlement is seen however the shear cracks are within acceptable levels and likely to be historic and non-progressive

Cracks create weakness in masonry and it is likely that these will continue to open-up due to thermal expansion

It is particularly important that render be kept waterproof otherwise inevitable surface cracking may allow damp penetration and it would be worthwhile filling these areas with a flexible mastic

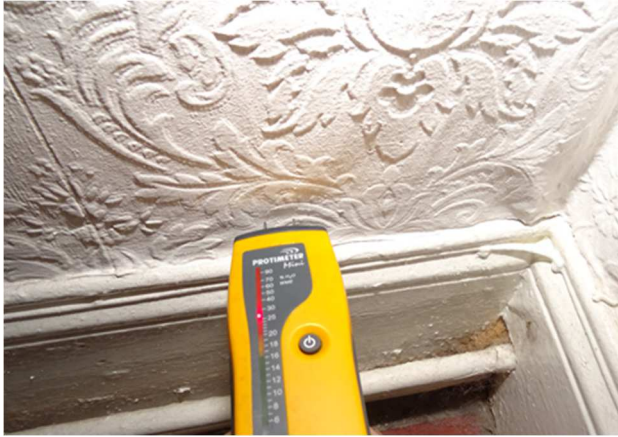
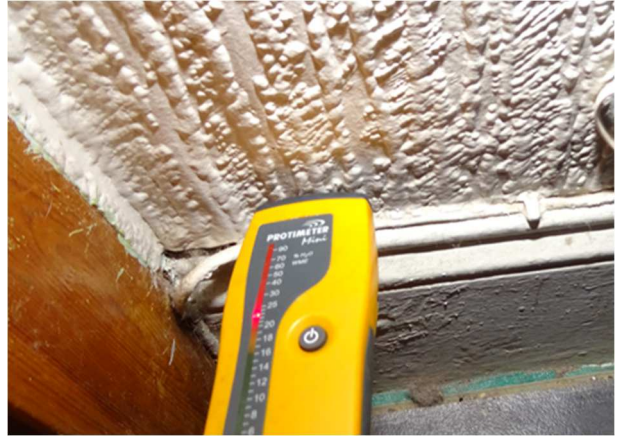
Internal moisture meter readings suggest that it is now ineffective in some areas (See Appendix A Photograph 7 and 8) and you are referred to item 3.18 of this report.

Evidence of excessive dampness was found to the Basement area in a several places. Rising damp generally rises to about one metre or so (a few feet) depending upon the type of walls and materials used etc.

The most likely cause is rising damp and specialist repairs and treatments may be necessary.

You are therefore recommended to instruct a specialist Property Care Association (PCA) registered contractor to investigate the cause and full extent of these faults and to carry out appropriate remedial work and allied repairs.

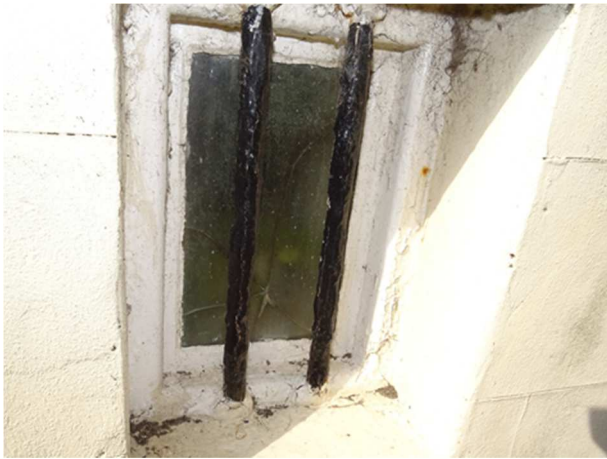
9

There is a small window on the ground floor to the WC room with a cracked window that will require replacement (See Appendix A Photograph 9)

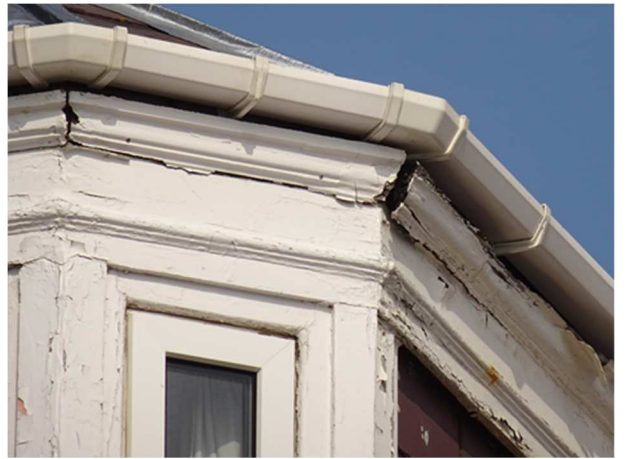
10

The Dormer window surrounds are rotten (See Appendix A Photograph 10). These will need comprehensive repair/replacement

These are poor in places, especially to the Dormer as noted above and full preparation and redecoration will be needed after wet rot repairs have been carried out

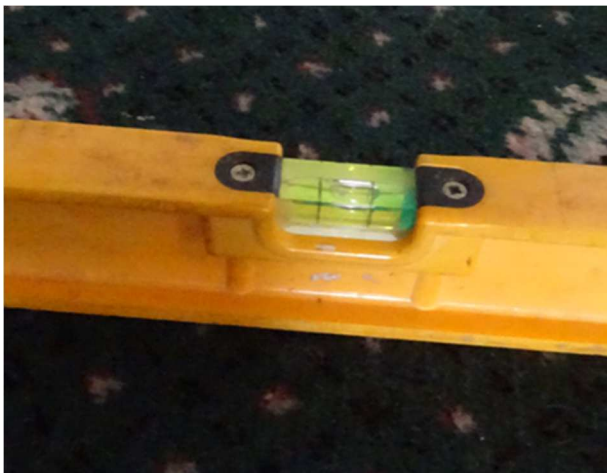
11

We noted the Hall floor is out of level (See Appendix A Photograph 11). This is however within normal tolerances

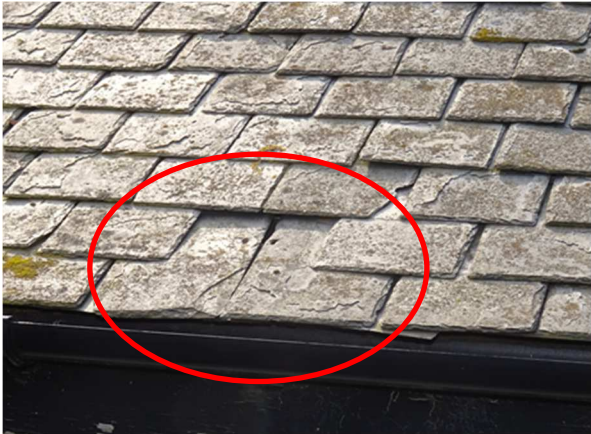
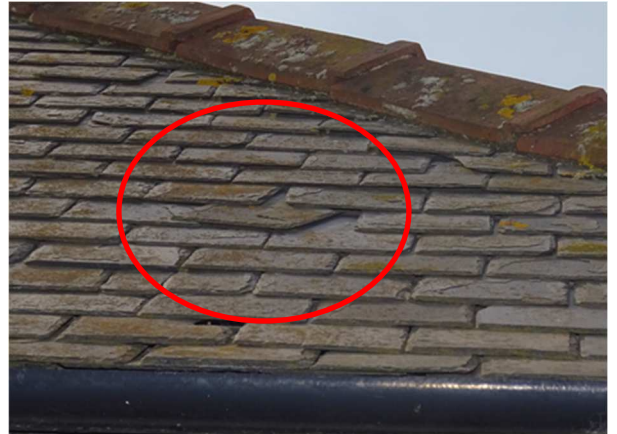
The condition appears adequate for current use but the roof covering appears to have used reclaimed slates when it was constructed and a number are cracked and will need replacing (See Appendix A Photograph 13 and 14, highlighted in red) and the hip tiles will need some rebedding, in particular the end hip tile (See Appendix A Photograph 15, highlighted in red)

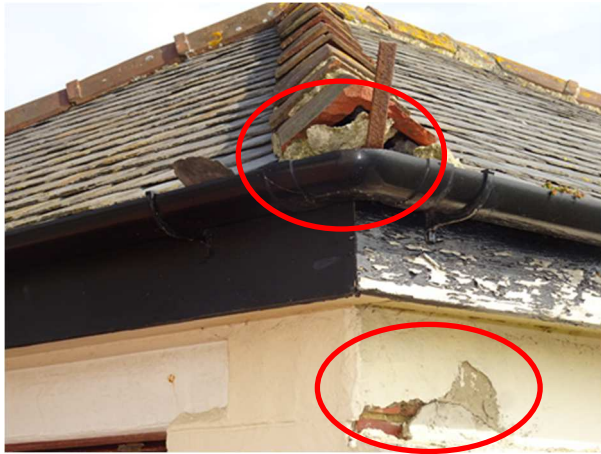
15

General maintenance and repainting will be required to some render damage at the right-hand side (See Appendix A Photograph 15, highlighted in red)

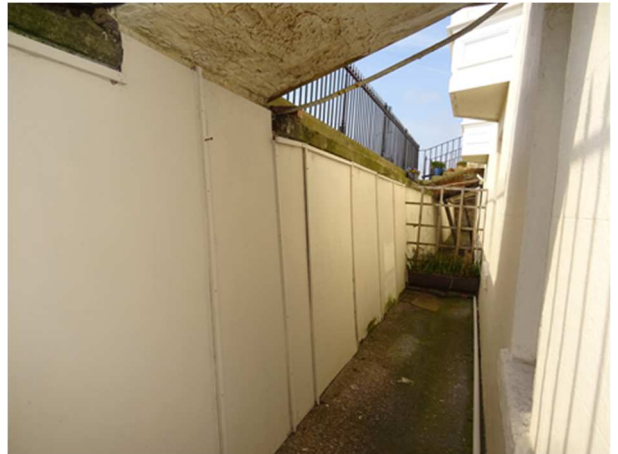
16

The basement to the property is below ground level in a retained section with timber fencing (See Appendix A Photograph 16, highlighted in red). This hides the condition of the walls so we are unable to comment on the condition. Further clarification of the condition and inspection is essential as these are prone to deflection and therefore maintenance costs will be higher than average.
